**EVALUATION OF NON-DESTRUCTIVE TECHNIQUES FOR
CORROSION DETECTION IN CONCRETE EXPOSED
TO A MARINE ENVIRONMENT**

**Prepared in cooperation with the State of Hawaii Department of Transportation,
Highways Division and U.S. Department of Transportation, Federal Highway
Administration**

Research Report UHM/CEE/05-04

May 2005

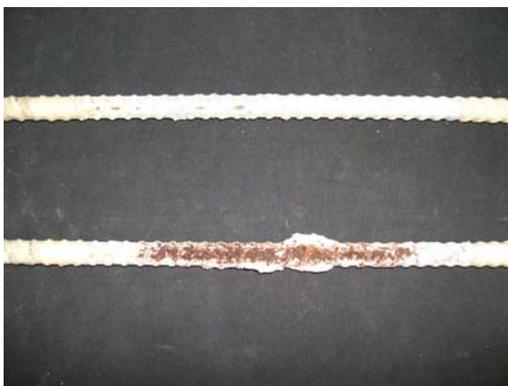
Figure 7.159 - Bars, bottom

Ferr5 #1 – The visual inspection of the outside of the specimen turned up nothing suspicious. The right bar was well covered in corrosion on the bottom. On the top of the right bar there were corrosion along the edges. The bottom of the left bar had pits and other small corrosion spots. The half cell potential indicated that all the values fell into the 10% probability range. The voltage readings showed that the specimen had failed. The inspection concluded the corrosion to be moderate to significant.

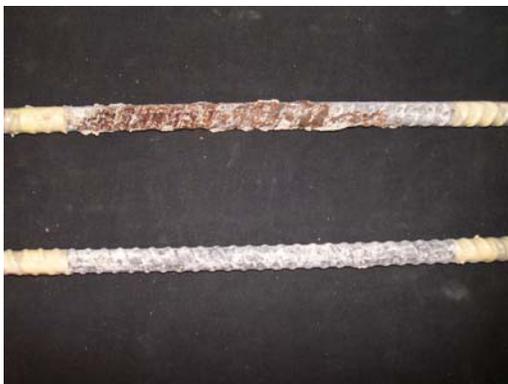
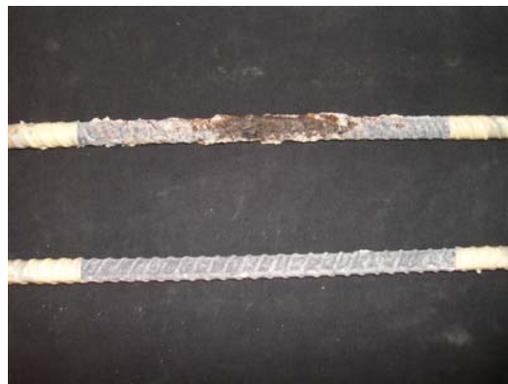
Figure 7.162 : Ferr5 #3 B

Ferr5 #3 – The visual inspection showed multiple cracks on the left of the top surface of the specimen. There were also cracks on the left side of the specimen. All of the corrosion occurred on the left bar. The left bar was basically covered on the top and bottom in corrosion. The half cell potential results indicated that two values on the left side fell into the 90% probability range. The other values all fell into the uncertain range. The voltage results showed that the specimen had failed. The inspection concluded the corrosion to be moderate to significant.

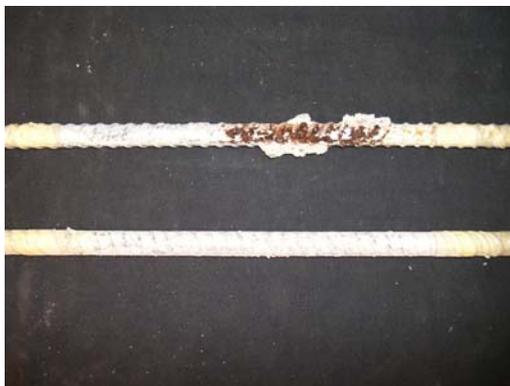
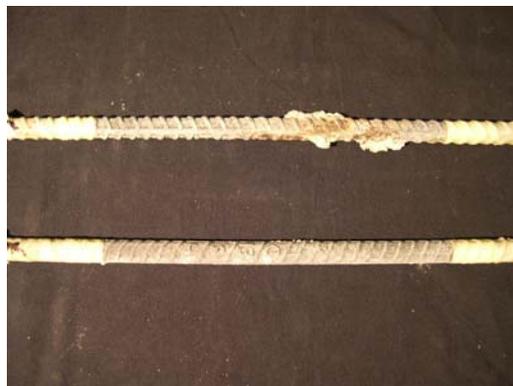
Figure 7.166 : Ferr5 #5B

Ferr5 #5 – The specimen looked in great condition from the outside. On the inside the left bar had a three inch area of corrosion located on both the top and the bottom. The right bar had a small area toward the front and bottom of the bar. The half cell potential readings showed two readings on the left and one on the right fell into the 10% probability range, the others fell into the uncertain range. The voltage data indicated the specimen had failed. The inspection concluded the corrosion to be moderate to significant.

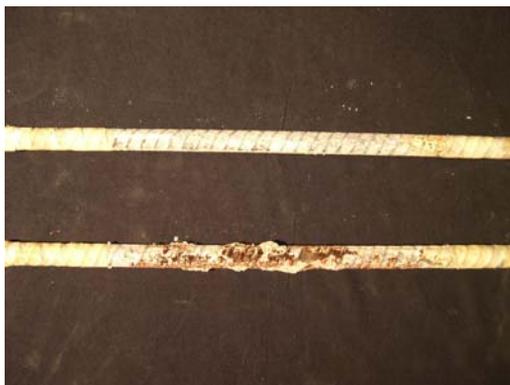
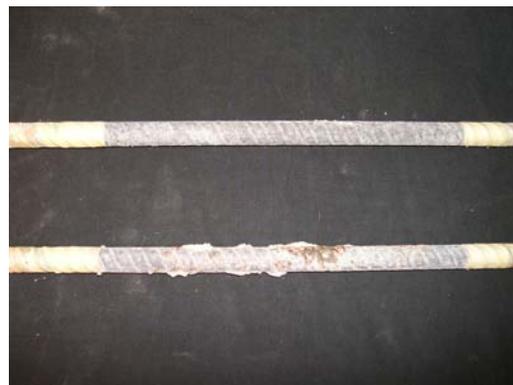
Figure 7.170 : Ferr5 #7B

Ferr5 #7 – From the outside the specimen looked in great condition. The right bar had lots of scattered corrosion on both the top and bottom of the bar. The half cell potential numbers showed one left side values in the uncertain range and all the rest in the 10% probability range. The voltage readings indicated that the specimen had failed. The inspection concluded the corrosion to be moderate to significant.

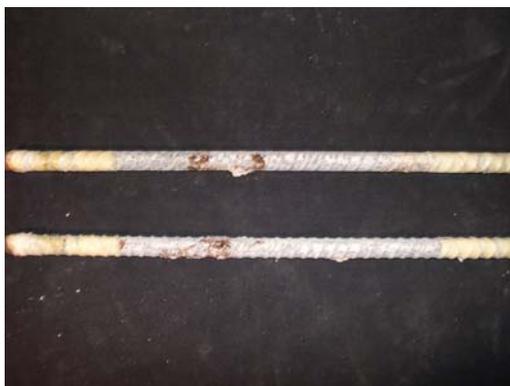
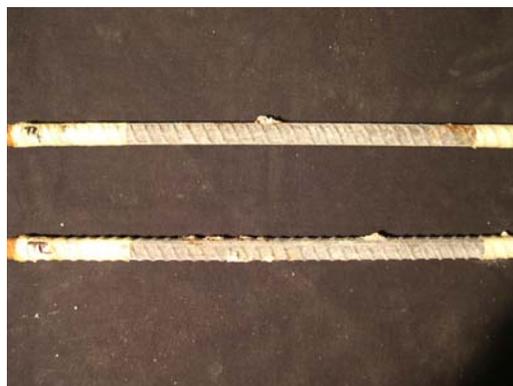
Figure 7.174 : Ferr5 #8 B

Ferr5 #8 – The visual inspection of the specimen did not turn up any fatal flaws. The specimen contained light areas of corrosion on both bars, and corrosion appearing on the top and bottom of both. The half cell potential results showed all the left side values fell into the 10% probability range. All the right side values fell into the uncertain range. The voltage data showed that the specimen did not reach failure. The inspection concluded the corrosion to be minor.

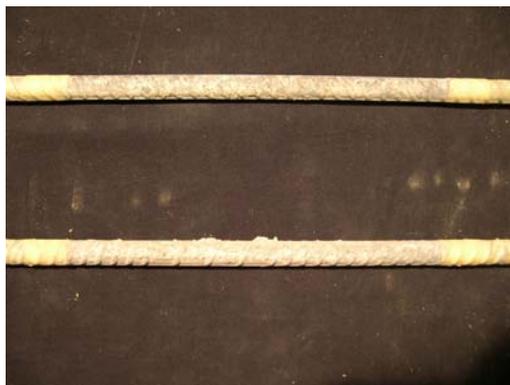
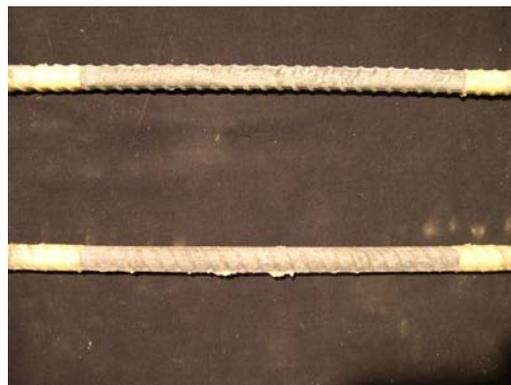
Figure 7.178 : Ferr6 #8 B

Ferr6 #8 – There was some web cracking on the surface of the specimen but it was very hard to see. The bars contained minimum corrosion. Corrosion pits appeared on the bottoms of both bars. The half cell potential readings showed all of the values were in the 10% probability range. The voltage data showed the specimen had not failed. The inspection concluded the corrosion to be none.

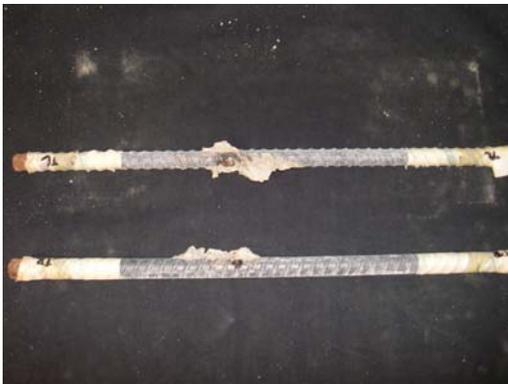
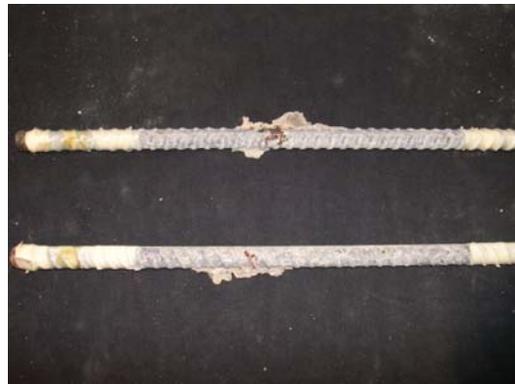
Figure 7.182 : HCon1 #1B

HCon1 #1 - On the outside, of the specimen there was no real visual damage. The inside of the specimen had small areas of corrosion on both rebar, on both the top and the bottom (top looks in worse condition). The half cell potential was almost to the uncertain range, but falls in the 10% range. The voltage results were getting very close to being considered to being failed. The inspection concluded the corrosion to be moderate to significant.

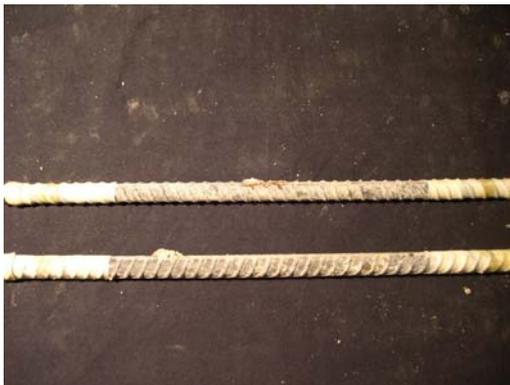
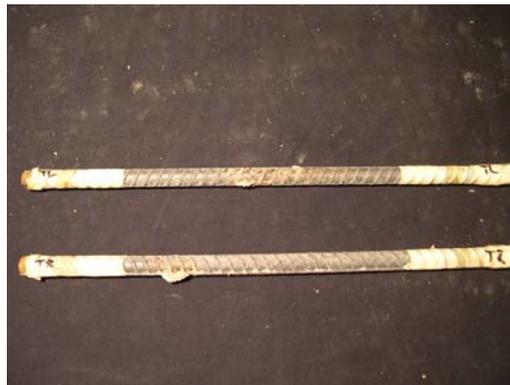
Figure 7.186 : HCon1 #2B

HCon1 #2 – The visual inspection on the outside did not show any particular flaws. The inside of the specimen the top of both bars have a light reddish haze on the top and a few spots on the bottom of the bars (more so on the left side). The half cell potential was very low, indicating that there is only a 10% of corrosion. The voltage results were also fairly low. The inspection concluded the corrosion to be minor.

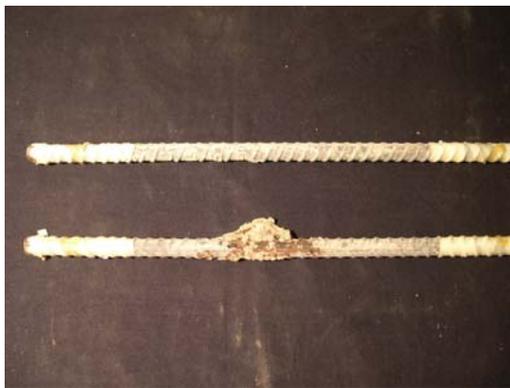
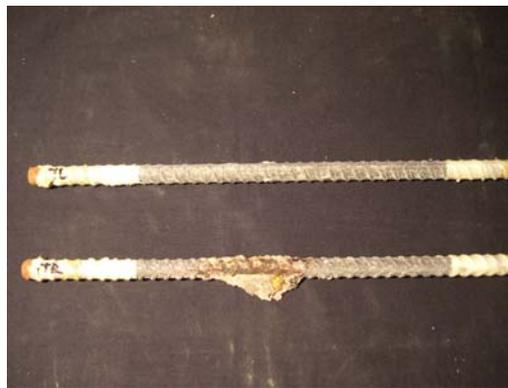
Figure 7.190 : HCon1 #3 B

HCon1 #3 – The visual inspection showed that there were cracks on the right side of the specimen, both on the top and the right side. As expected there was a large area of corrosion in the areas of the cracks, the corrosion was located on both the top and the bottom. The half cell potential numbers were fairly high on both sides. The left side had one reading in the 90% probability range and the other two being very close. The right side has all the values being in the 90% probability range. The voltage results were also high, with the specimen failing. The inspection concluded the corrosion to be moderate to significant.

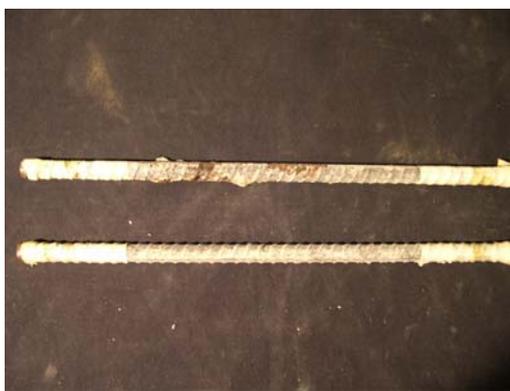
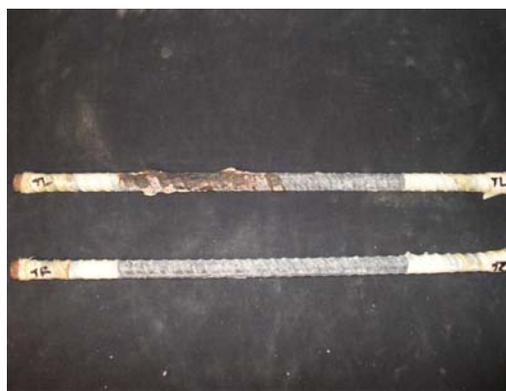
Figure 7.194 : HCon1 #4B

HCon1 #4 – The visual inspection showed cracks on the left side, on both the top and side of the specimen. The corrosion only appeared in the area of the cracks on the left side. The corrosion appeared more severe on the top of the left bar than on the bottom. The half cell potential numbers were high on both sides, but the highest numbers appeared on the left side toward the front. There were two values on the left side that were in the 90% range and one on the right. The voltage results were the highest of all the HCon1 specimens. The inspection concluded the corrosion to be moderate to significant.

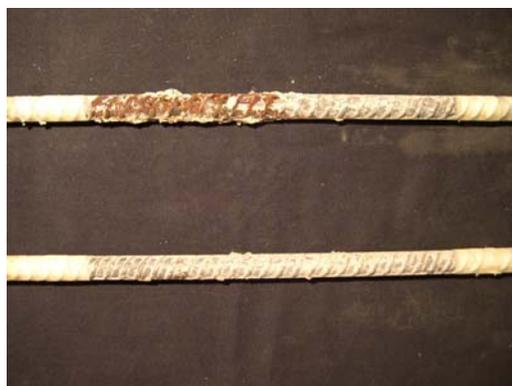
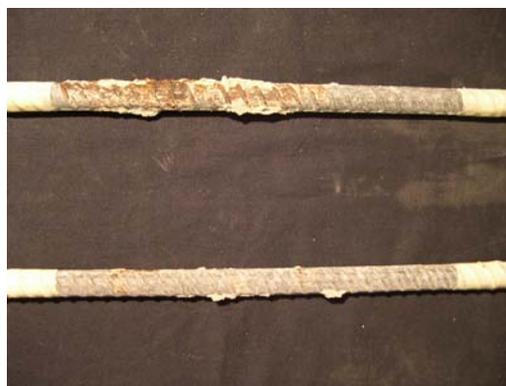
Figure 7.198 : HCon2 #1B

HCon2 #1 – The visual inspection showed cracks on the left side, on both the top and front side of the specimen. The majority of the corrosion appeared on the left side, but there were a few spots on the right side also. The corrosion seems more severe on the bottom of the left bar. The half cell potential numbers were high, more so on the left side. The left side had two values in the 90% range, with the other values being high but in the uncertain designation. The voltage results showed that the specimen had failed. The inspection concluded the corrosion to be moderate to significant.

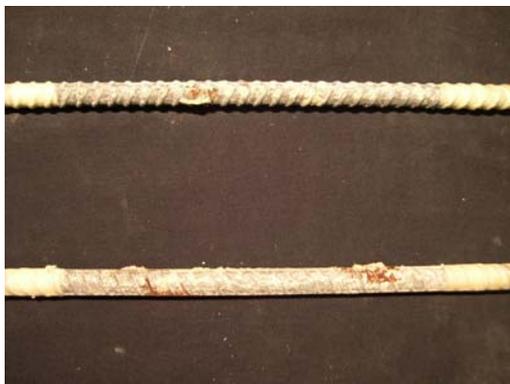
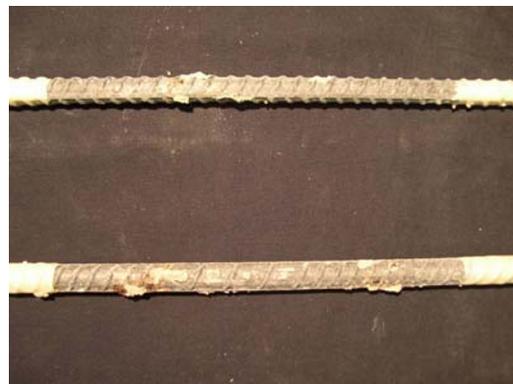
Figure 7.202 : HCon2 #2B

HCon2 #2 – The visual inspection showed no major flaws on the outside of the specimen. Inside of the specimen there are a few corrosion areas on both the left and right side. The right side had a little bit more corrosion than the left side. The corrosion on the top and the bottom seems to be of similar degrees. The half cell potentials numbers are on the low side. All the values fell within the 10% probability of corrosion range. The voltage numbers were just beginning to get to the point of failure. The inspection concluded the corrosion to be minor.

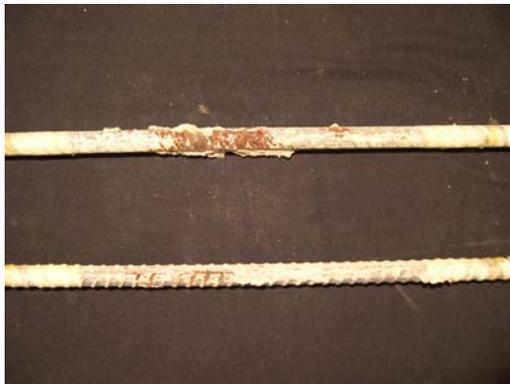
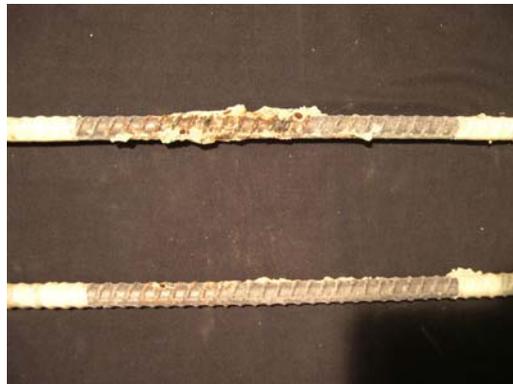
Figure 7.206 : HCon2 #3B

HCon2 #3 – The visual inspection showed a small crack on the top of the specimen, above the left bar. The inside of the specimen showed the majority of the corrosion on the left side. There was also a small area of corrosion on the right side. The corrosion on the top of the left bar looked harsher than the bottom. The half cell potential readings on the left side fell in the uncertain range, while the values on the right side are all in the 10% corrosion range. The voltage numbers were very close to being considered for failure. The inspection concluded the corrosion to be moderate to significant.

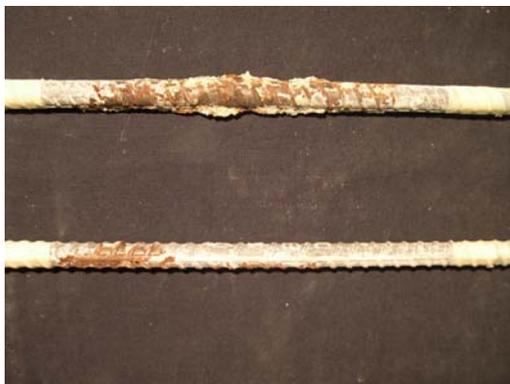
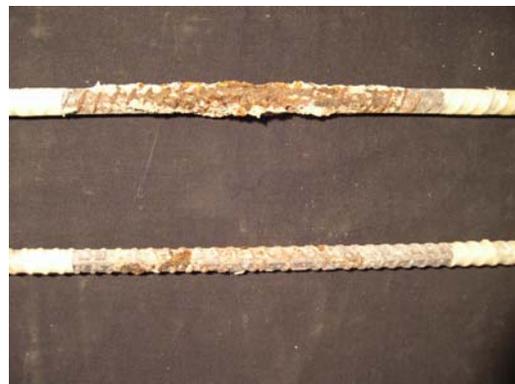
Figure 7.210 : HCon2 #4B

HCon2 #4 – The visual inspection showed a large crack above the left bar, there was also a large crack on the left side. On the inside the left bar was well covered in corrosion on both the top and the bottom. The right bar was fairly well covered on the bottom and there are a few spots on the top. The half cell potential results showed two values on the left side fell in the uncertain range. All the other values fell in the 10% probability of corrosion range. The voltage results were the worst of the group, the specimen was considered failed. The inspection concluded the corrosion to be moderate to significant.

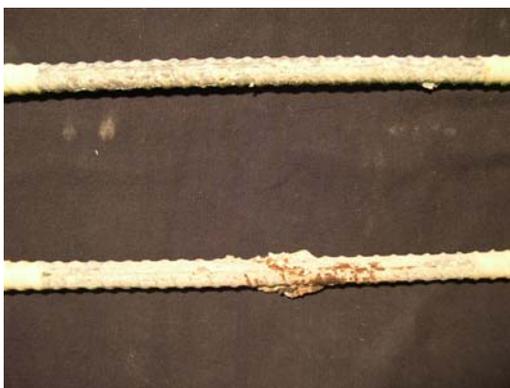
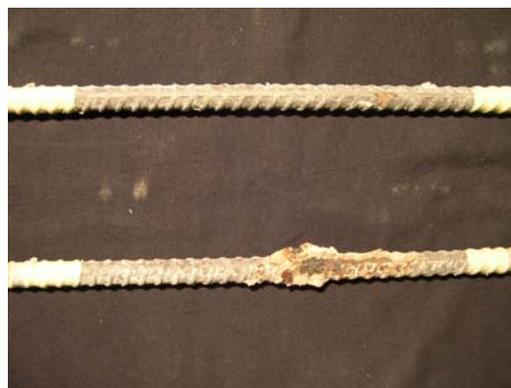
Figure 7.214 : HCon4 #1B

HCon4 #1 – The visual inspection did not show any suspicious voids or cracks on the outside. On the inside there was a medium sized area of corrosion on the top and the bottom of the right bar. The left bar had a small corrosion area on the top and a few orange pits on the bottom. The half cell potential results indicate on the left side the values were in the uncertain range. There was one value on the right side that lands in the 90% probability of corrosion range. This specimen was the only one of the group that met the criteria for failure. The inspection concluded the corrosion to be moderate to significant.

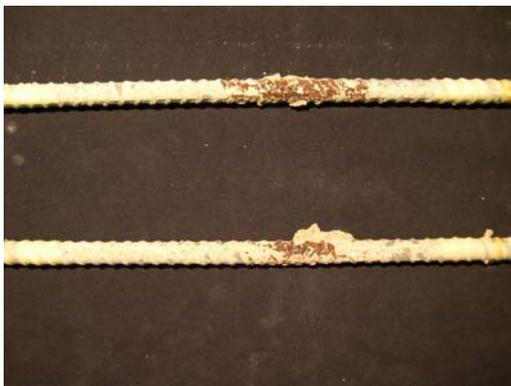
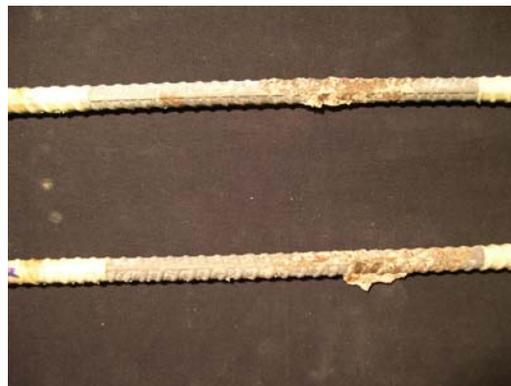
Figure 7.218 : HCon5 #1B

HCon5 #1 – The visual inspection did not show anything suspicious. The inside contained corrosion on both bars from the middle to the back. There was a greater amount of corrosion on the top of the bars, but the corrosion located on the bottom looked to be more detrimental. The corrosion was worse on the left bar. The half cell potential reading showed that all the values on the left side were in the 10% probability range. Two of the values on the right fell into the uncertain range. The voltage readings did not reach failure. The inspection concluded the corrosion to be moderate to significant.

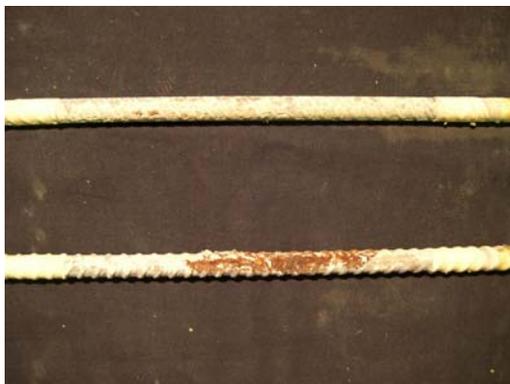
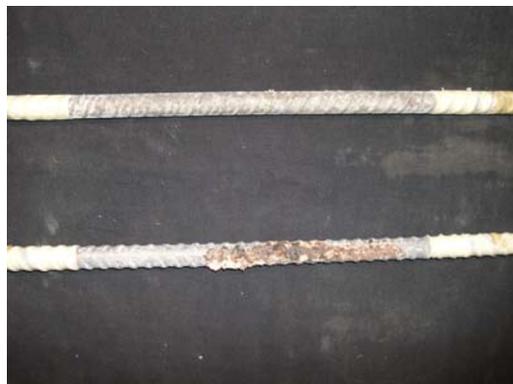
Figure 7.222 : HCon5 #2B

HCon5 #2 – The visual inspection showed a crack about 1.5 inches long on the top surface, above and parallel to the right reinforcement. There is also a small crack on the right side of the specimen. Inside the specimen the most of the corrosion was on the right bar, on both the top and bottom. The left bar had pits along the length of the bottom of the bar. The half cell potential reading show that all the values fell in the uncertain range. The voltage readings indicated failure. The inspection concluded the corrosion to be moderate to significant.

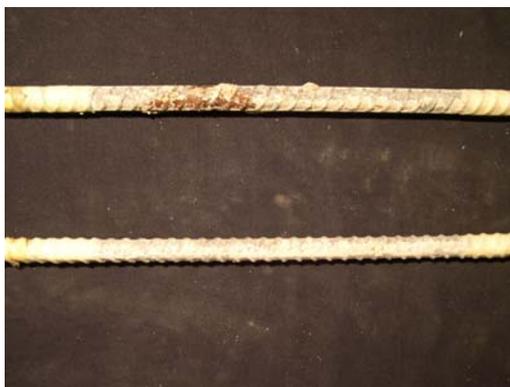
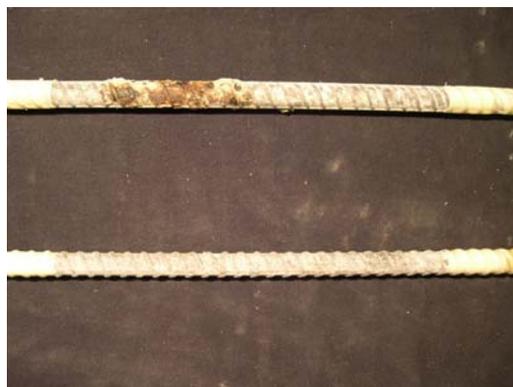
Figure 7.226 : HCon5 #3B

HCon5 #3 – The specimen looked to be in good condition on the outside. On the inside the majority of the corrosion was located on the left bar. The corrosion on the top of the left bar was more concentrated than on the bottom. The right bar had only a few pits on the bottom of the bar. The half cell potential readings show that all of the values were in the uncertain range. The voltage readings indicated the specimen has failed. The inspection concluded the corrosion to be moderate to significant.

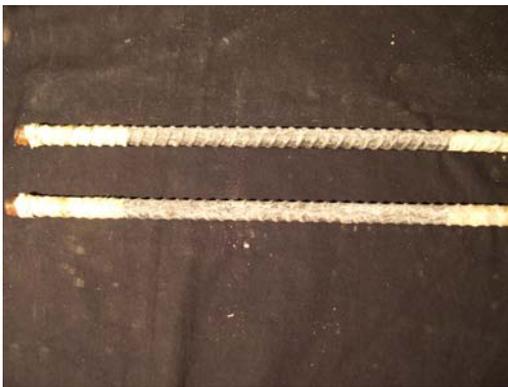
Figure 7.235 - Bars, bottom

HFA5 #1 – The top surface has some web cracking occurring. There are also some small indentations and discolorations. The bars on the inside have absolutely no corrosion on them. The half cell potential values all fell into the 10% probability range. The voltage results showed that the specimen had not failed. The inspection concluded the corrosion to be none.

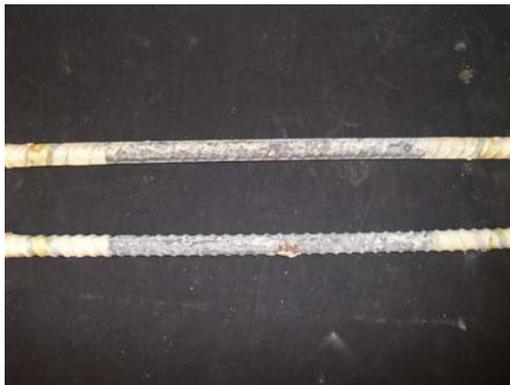
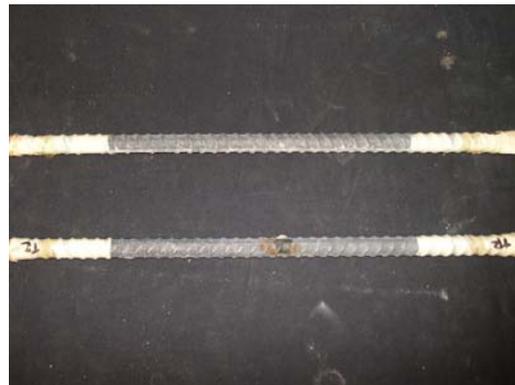
Figure 7.238 : HFA5 #2 B

HFA5 #2 – The top surface has web cracking occurring. The right bar has a small area of corrosion on the top. The area of corrosion spills off to the bottom of the bar as well. The half cell potential readings all fell into the uncertain range. The voltage data showed that the specimen had failed. The inspection concluded the corrosion to be moderate to significant.

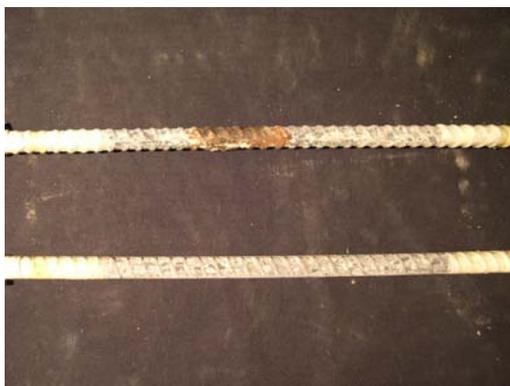
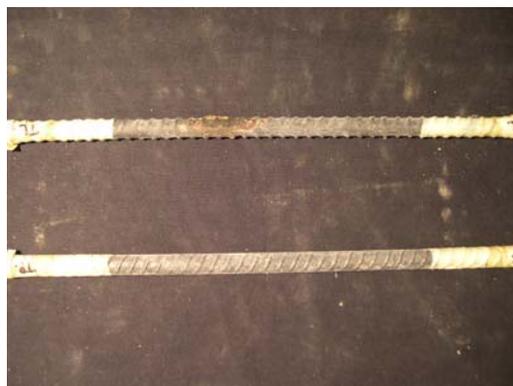
Figure 7.242 : HFA5 #3 B

HFA5 #3 – There was a crack on the top surface above the left bar. There were also cracks on the left side of the specimen. The left bar has a 2.5 inch area of corrosion on the top and bottom of the bar. The half cell potential results showed that one value on the left side fell into the 90% probability range. All the other results fell into the uncertain range. The voltage data showed that the specimen had failed. The inspection concluded the corrosion to be moderate to significant.

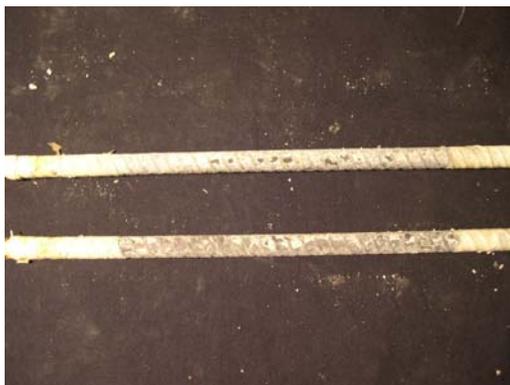
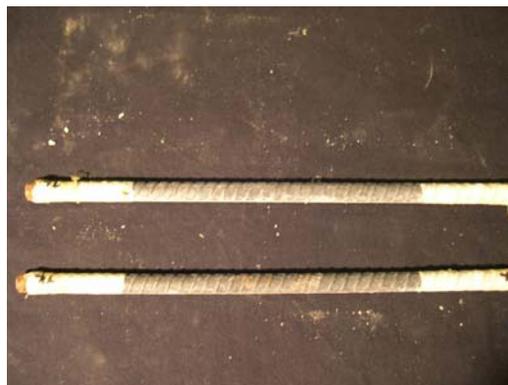
HFA5 #4 – There was clear web cracking on the top surface. There were a few spot of corrosion on the top of the right bar. There were no other areas of corrosion located on both bars. The half cell potential values all fell into the 10% probability range. The voltage data concluded that the specimen had not failed. The inspection concluded the corrosion to be none.

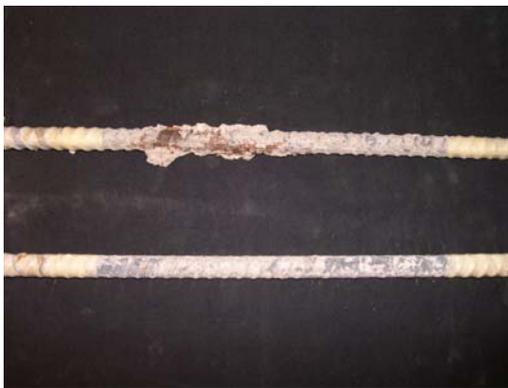
Figure 7.251 - Bars, bottom

HRrheo4 #1 – The visual inspection showed a crack on the top surface on the left side. There were also cracks on the left side of the specimen. The majority of corrosion was located on the top of the left bar from the middle to the front. The bottom of the left bar has some corrosion but less than the top. There was a little bit of corrosion on the bottom of the right bar. The half cell potential number indicated that all the values fell into the 10% probability range. The voltage data showed that the specimen had failed. The inspection concluded the corrosion to be moderate to significant.

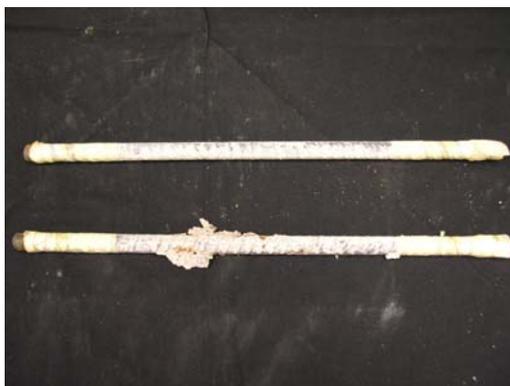
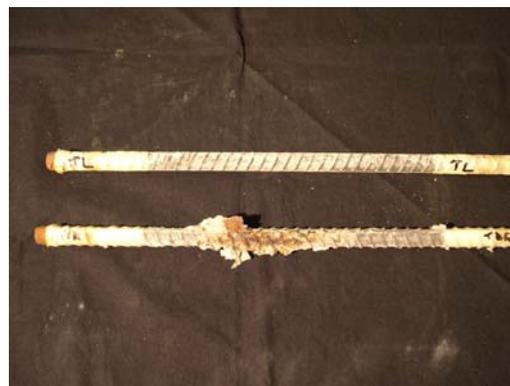
HRheo4 #2 – There was a crack on the right side of the top surface. There was also a crack on the right side of the specimen. On the inside of the specimen there was an area of corrosion on the right bar on the top around 1.5 inches long. The half cell potential readings showed that all the values fell into the uncertain range. The voltage data indicated that the specimen had failed. The inspection concluded the corrosion to be moderate to significant.

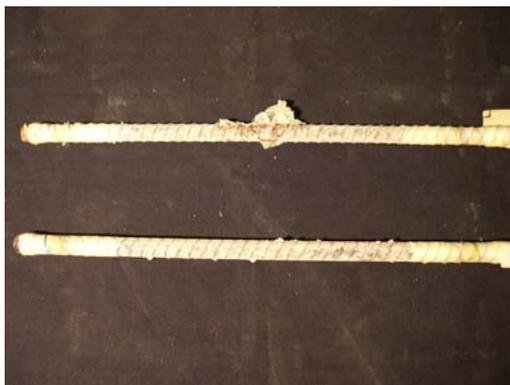
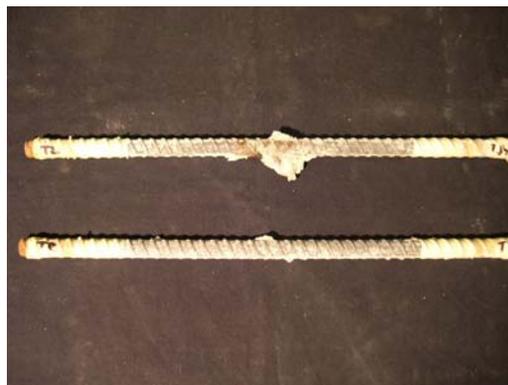
HRheo4 #3 – There were some small voids scattered over the top. The specimen showed no other signs of distress. The left bar had a small area of scattered corrosion on both the top and bottom. The half cell potential values all fell into the 10% probability range. The voltage results showed that the specimen was slowly moving toward failure. The inspection concluded the corrosion to be minor.

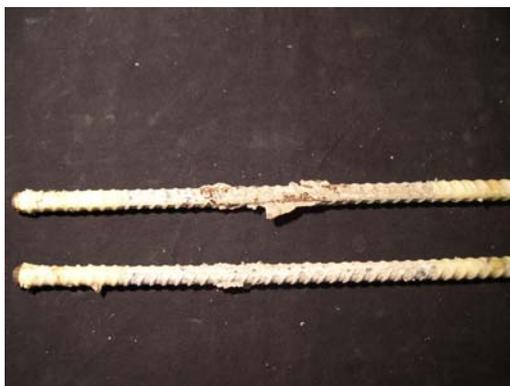
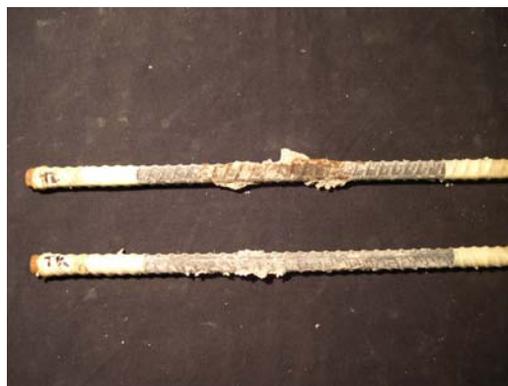
HRheo4 #4 – The specimen has a crack on the top surface above the left bar. There is corrosion on the left bar on both the top and the bottom. The corrosion was spread out around certain small concentrated areas. The half cell potential values showed that one value on the left side fell into the 90% probability range. All the other values fell into the uncertain range. The voltage data showed that the specimen had failed. The inspection concluded the corrosion to be moderate to significant.

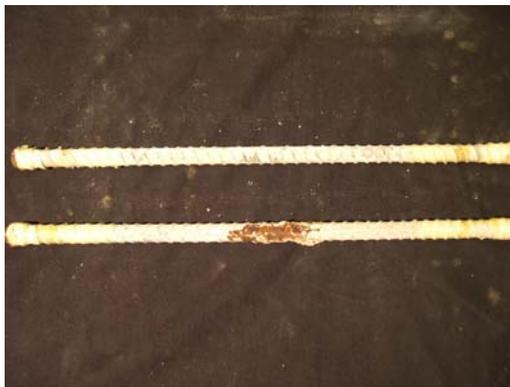
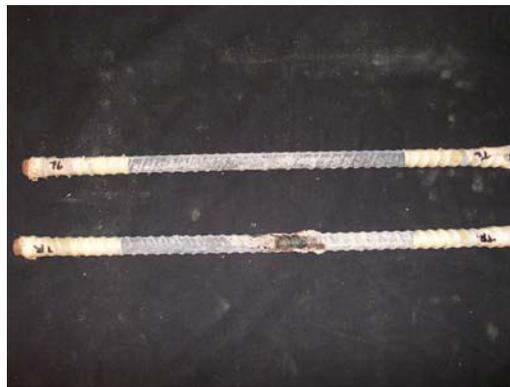
HRheo5 #1 – From the outside the specimen looked in excellent condition. There was small corrosion area located on the right bar on both the top and bottom. The half cell potential readings show one value on the right side fell into the 90% probability range. All the other values fell into the uncertain range. The voltage readings showed the specimen was getting close to failure. The inspection concluded the corrosion to be moderate to significant.

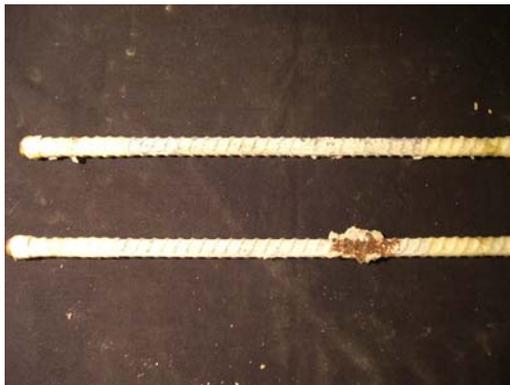
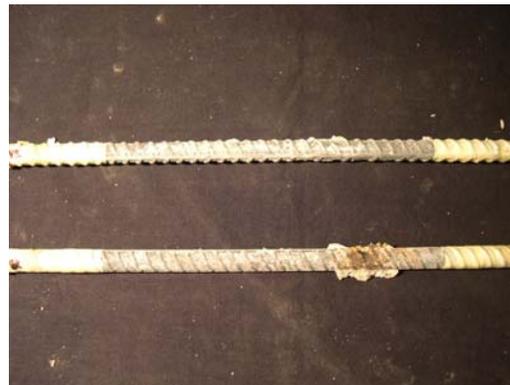
HRheo5 #2 – The specimen has no major flaws on the outside. The right bar has a small area of corrosion on both the top and bottom toward the back of the bar. The half cell potential values all fall into the uncertain range. The voltage readings showed that the specimen was getting closer to failure, but not there yet. The inspection concluded the corrosion to be moderate to significant.

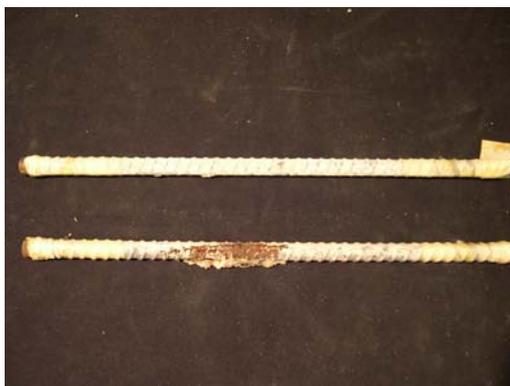
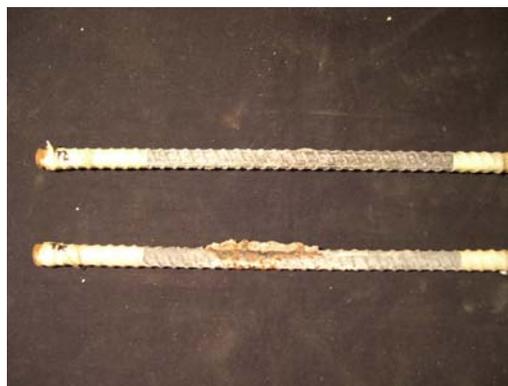
HRheo5 #3 – The top surface has two small voids on the left side. There were no other flaws. The right bar has an area of 3 inches of corrosion on the top and bottom of the bar. The half cell potential values showed one value on the right and left fell into the uncertain range. All the other values fell into the 90% probability range. The voltage data showed that the specimen had failed. The inspection concluded the corrosion to be moderate to significant.

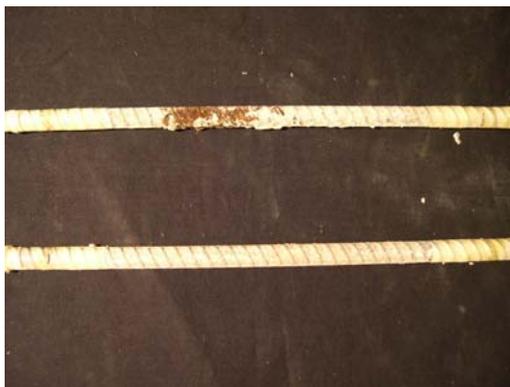
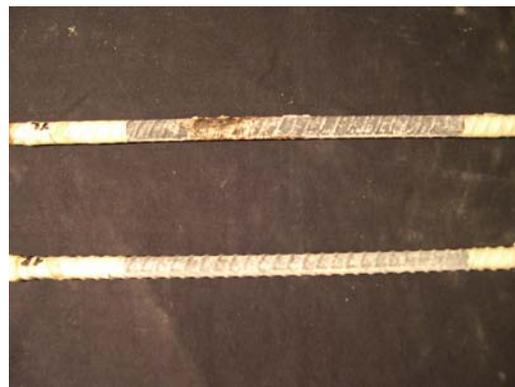
HRheo5 #4 – The specimen showed no critical flaws on the outside. The left bar has an area of about 2 inches corrosion on both the top and the bottom. The half cell potential values showed one value on the left side fell into the 90% probability range. All the other values fell into the uncertain range. The voltage readings showed the specimen had failed. The inspection concluded the corrosion to be moderate to significant.

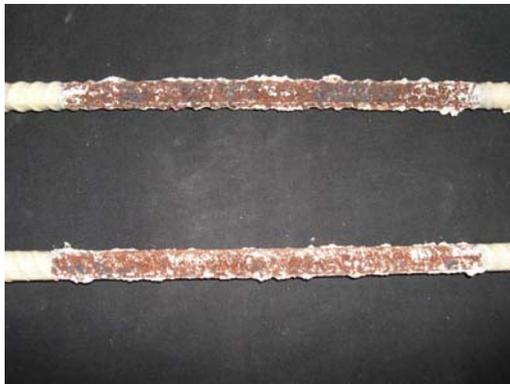
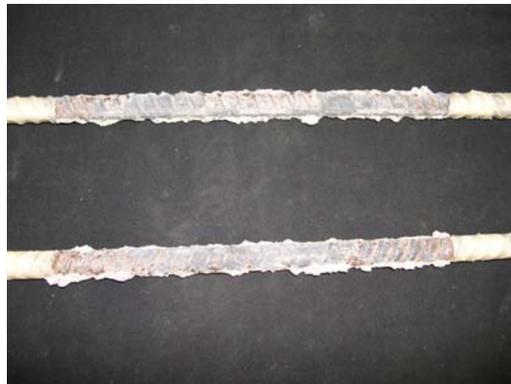
LA1 #1 – The visual inspection showed no critical flaws on the outside of the specimen. The bottoms of both bars are completely covered in corrosion. The tops of both bars also have corrosion pits and spots all along the surface. The half cell potential numbers showed all the values fell into the uncertain range. The voltage readings indicated showed that the specimen was not close to failure. The inspection concluded the corrosion to be moderate to significant.

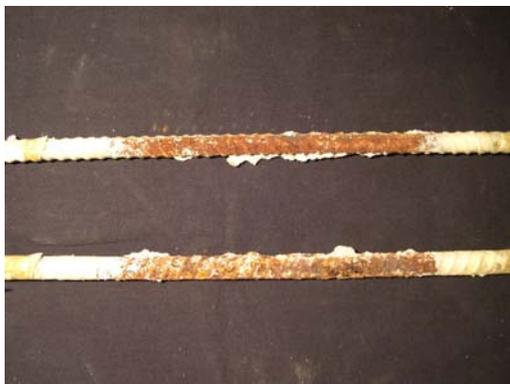
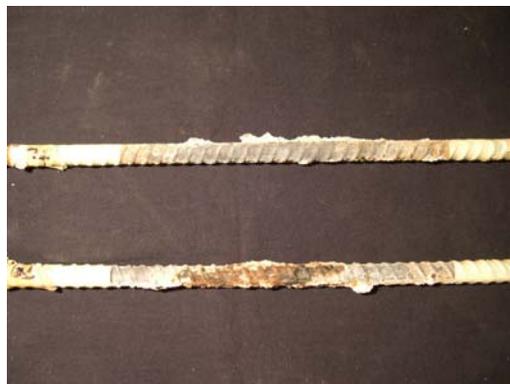
LA1 #2 – The visual inspection revealed a crack on the top surface around the right bar. There were also cracks on the right side of the specimen. Inside the specimen corrosion was found on the tops of both bars. The corrosion was more concentrated on the right bar, while the left bar corrosion was more along the edges. The half cell potential results indicated all the values fell into the uncertain range. The voltage readings showed the specimen had failed. The inspection concluded the corrosion to be moderate to significant.

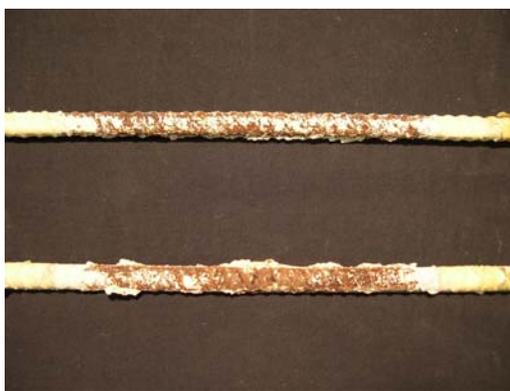
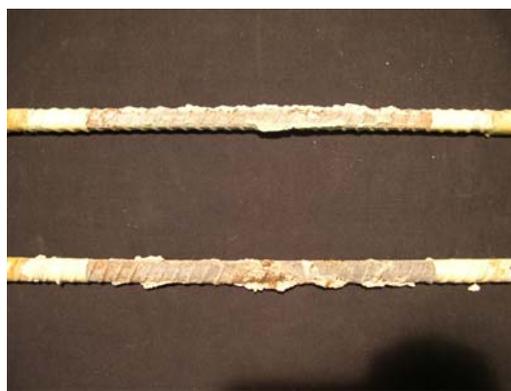
LA1 #3 – The top surface of the specimen looked in good condition. There were small cracks underneath the epoxy coating on both sides. Both bars were well covered in corrosion especially on the bottoms. The tops of the bars had many spots of corrosion along the length of the bars. The half cell potential readings showed that all of the numbers on the left side and one value on the right side fell into the 10% probability range. The other two values fell into the uncertain range. The voltage data indicated that the specimen had failed. The inspection concluded the corrosion to be moderate to significant.

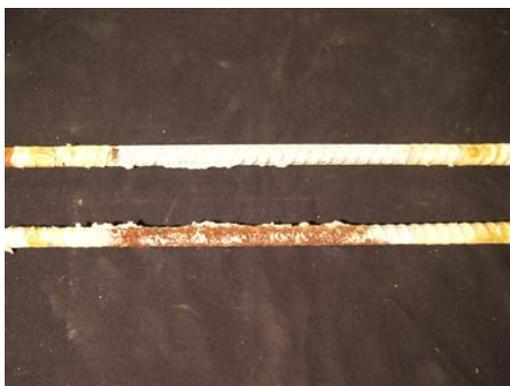
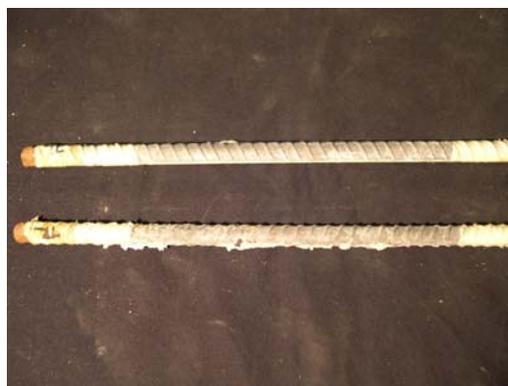
LA1 #4 – The top surface of the specimen contained web cracking. Everything else of the outside of the specimen looked in good condition. There were corrosion on both bars but the majority occurred on the bottom of the right bar. The top of the right bar had corrosion along the edges. The bottom of the left bar contained a small area of corrosion. The half cell potential numbers showed that all the values fell into the uncertain range. The voltage readings indicated that the specimen had not failed. The inspection concluded the corrosion to be moderate to significant.

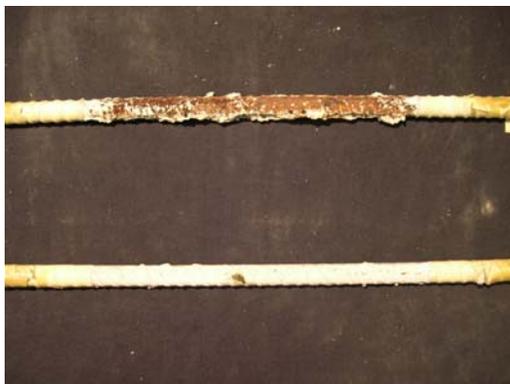
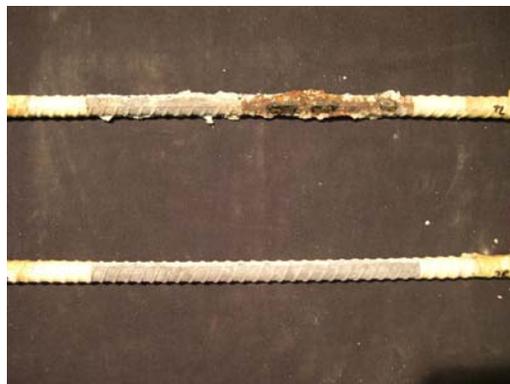
LA1 #5 – The visual inspection showed a long crack on the top surface above the left bar. There was also a smaller crack above the right bar. The left side of the specimen showed multiple cracks mostly toward the back. The left bar was covered in corrosion on both the top and bottom of the bar. The right bar had a few pits of corrosion on the bottom. The half cell potential readings all fell into the uncertain region. The voltage data showed that the specimen had failed. The inspection concluded the corrosion to be moderate to significant.

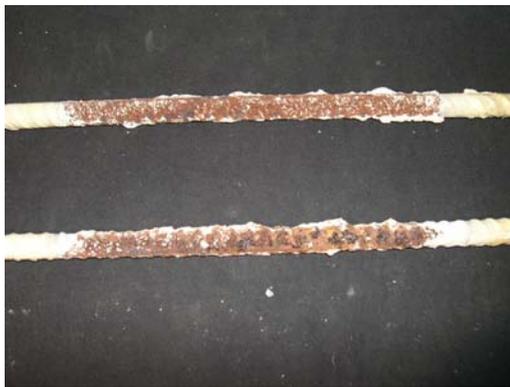
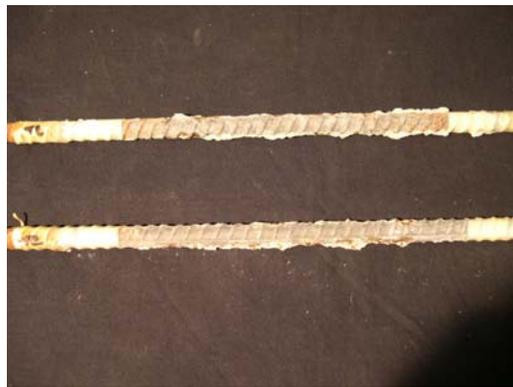
LA1 #6 – The specimen looked great from the outside. Both bars are completely covered in corrosion on the bottoms of the bars. The tops of the bars have spots or scattered areas of corrosion both toward the back and the front. The corrosion on the tops was more severe on the left side. The half cell potential readings all fell into the uncertain range. The voltage data showed the specimen had failed. The inspection concluded the corrosion to be moderate to significant.

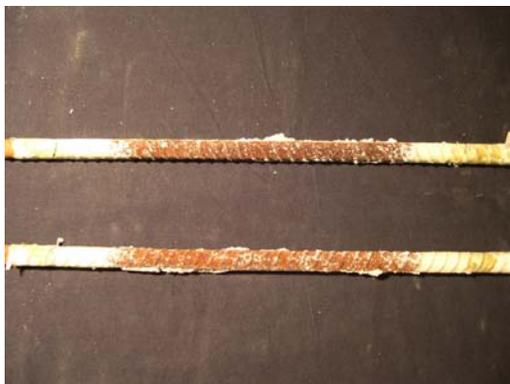
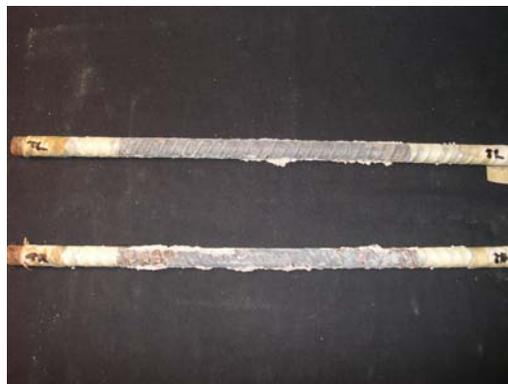
LA1 #8 – The top surface looked like there was some web cracking. Everything else looked fine. On the inside both bars were covered with corrosion on the bottoms. There was minimal corrosion on the top with small areas toward the front and back of both bars. The half cell potential readings showed that all the values on the left side fell into the 10% probability range. All the values on the right side fell into the uncertain range. The voltage data indicated the specimen had not failed but it was getting close. The inspection concluded the corrosion to be moderate to significant.

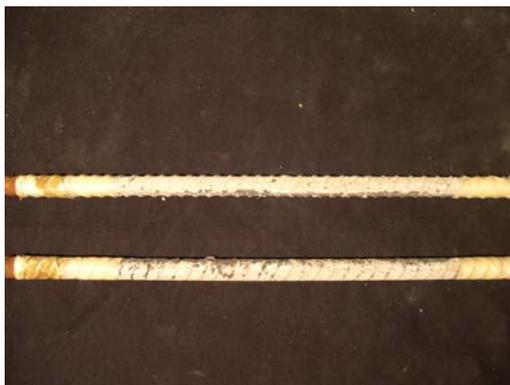
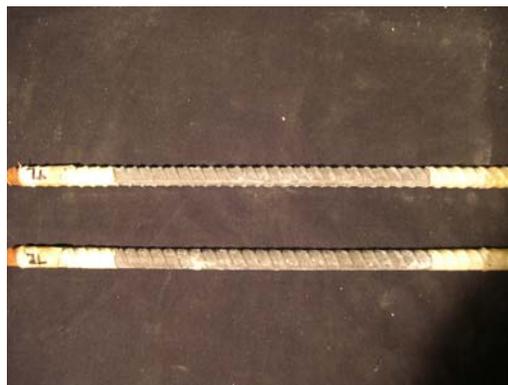
LA2 #8 – The outside of the specimen has some light brown discoloration toward the bottom of the top surface. On the inside of the specimen there was virtually no corrosion. The half cell potential values all fell into the 10% probability range. The voltage readings showed the specimen had not failed. The inspection concluded the corrosion to be none.

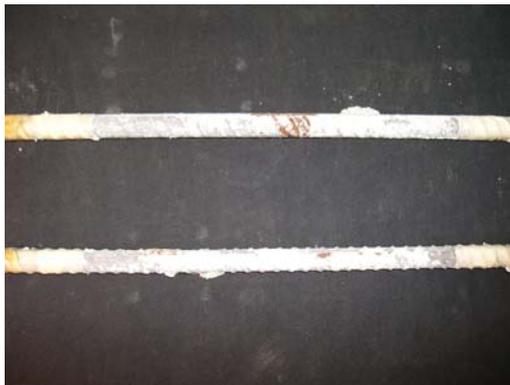
Figure 7.315 - Bars, bottom

LA3 #7 – The outside surface contained no critical problems. Both bars have small areas of corrosion on both the top and bottom of the bars. The corrosion was not wide spread. The half cell potential values all fell into the uncertain range. The voltage readings showed the specimen was close to failure but had not reached it. The inspection concluded the corrosion to be minor.

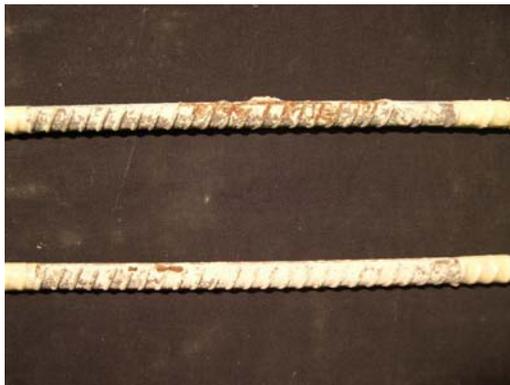
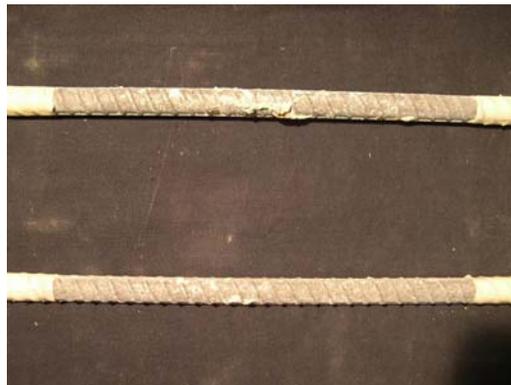
LA3 #8 – The visual inspection did not indicate any flaws on the outside. On the left bar there were pits on the top and strip of corrosion on the edge of the bottom of the bar. The right bar contains pits on both the top and the bottom. The half cell potential values all fell into the uncertain range. The voltage data indicated that the specimen had not failed. The inspection concluded the corrosion to be moderate to significant.

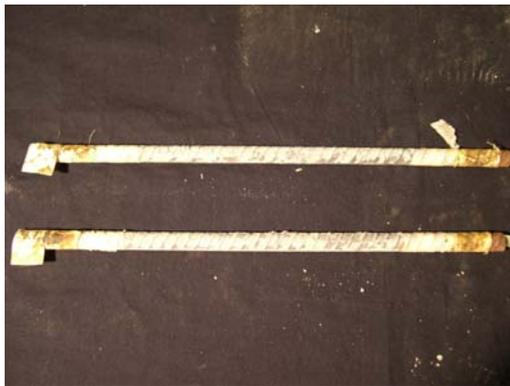
Figure 7.323 - Bars, bottom

LA5 #8 – From the outside the specimen looks in excellent condition. There is minimal corrosion on the inside of the specimen. The half cell potential values all fell into the 10% probability range. The voltage readings showed that the specimen had not failed. The inspection concluded the corrosion to be none.

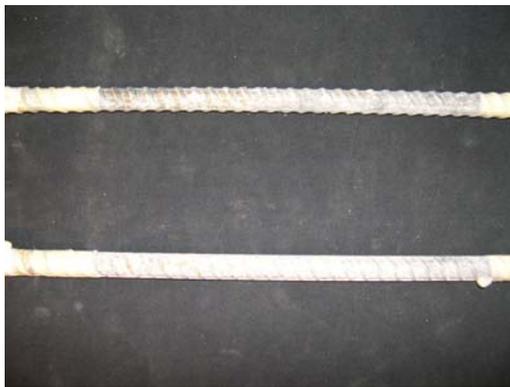
Figure 7.331 - Bars, bottom

Rheo1 #8 – The visual inspection revealed a small crack on the top surface that occurred to the left of the right bar. There was also some web cracking occurring. Both bars showed some consistent spaced corrosion on the bottoms. The half cell potential values all fell into the 10% probability range. The voltage readings indicated that the specimen had not failed. The inspection concluded the corrosion to be minor.

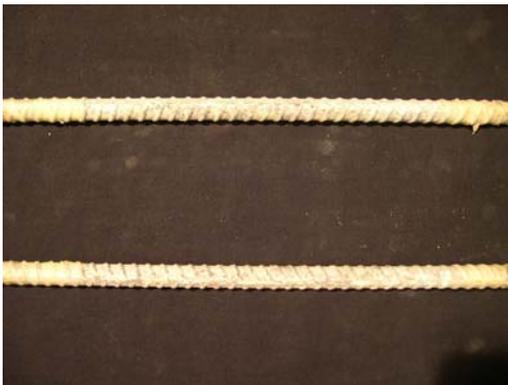
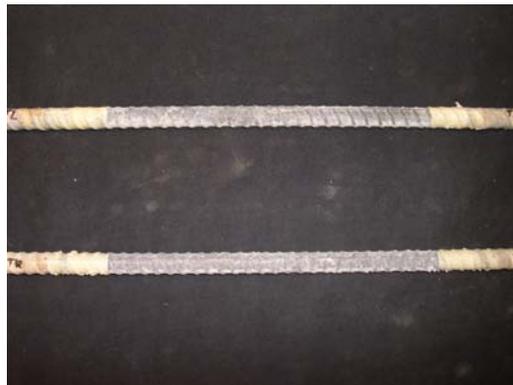
Rheo2 #8 – There were a few void on the top surface. Otherwise the specimen looked to be in good condition. There were only a few pits of corrosion on bottom of both bars combined. The half cell potential values all fell into the 10% probability range. The voltage data showed that the specimen had not failed. The inspection concluded the corrosion to be none.

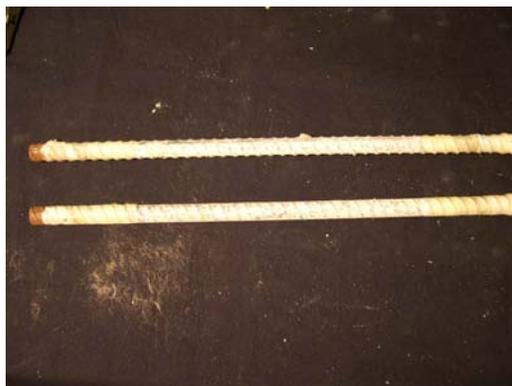
Figure 7.343 - Bars, bottom

Rheo4 #8 – On the outside the specimen appeared to be in excellent condition. Both bars were clean. The half cell potential readings showed the values in the 10% probability range. The voltage data pointed out that the specimen had not failed. The inspection concluded the corrosion to be none.

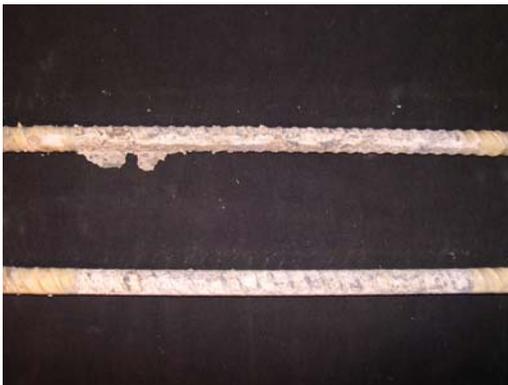
Figure 7.347 - Bars, bottom

Rheo5 #8 – The outside of the specimen looked in fair condition. There are some discolorations and tiny cracks. The bars showed very little corrosion. There were a few spots on the bottom of both bars. The half cell potential values all fell into the 10% probability range. The voltage data indicated that the specimen had not failed. The inspection concluded the corrosion to be minor.
